Morganza Control Structure & the Mississippi River Flood Fight

T. (Jerry) Shih, Ph.D., P.E.
David J. Vossen, P.E.
Amena M. Henville, P.E., PMP

U.S. Army Corps of Engineers
New Orleans District
April 15, 2019

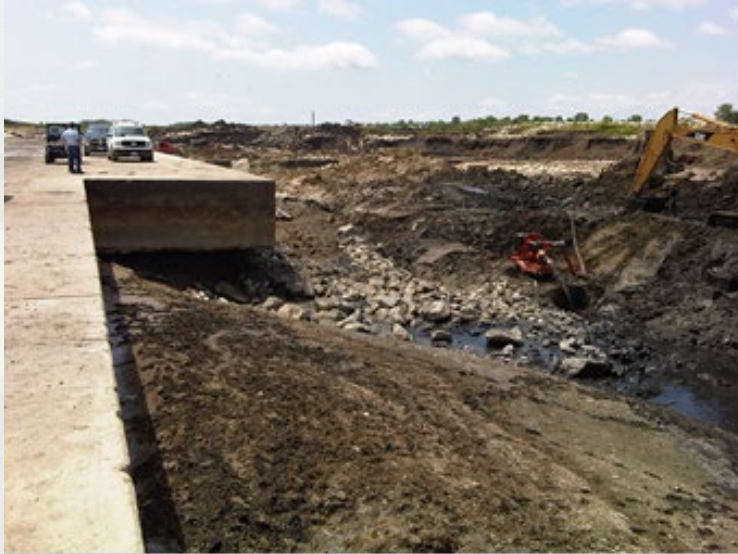
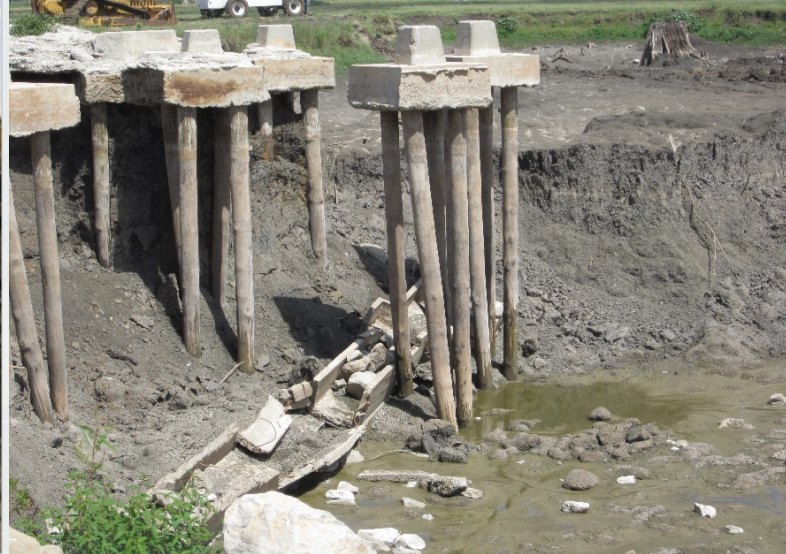
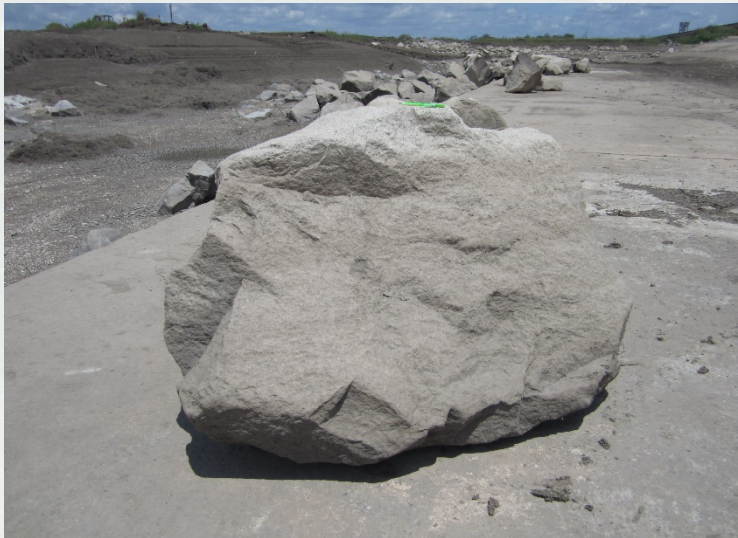
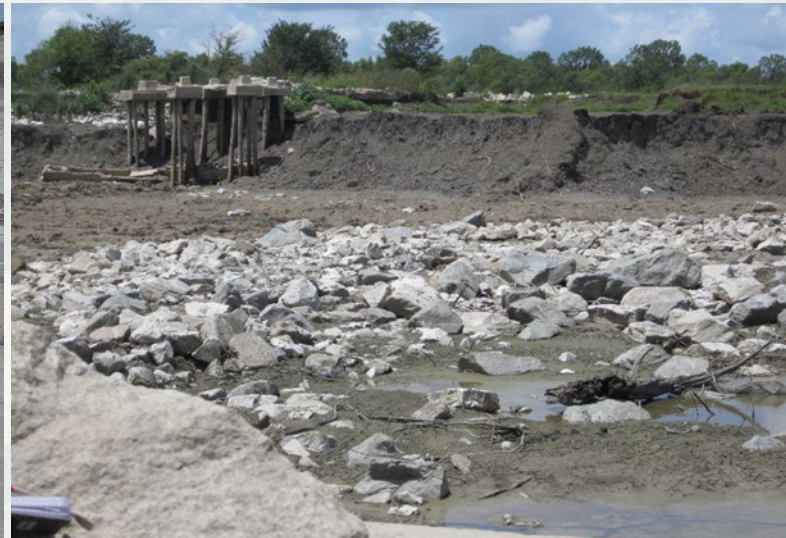
2011 Operation MCS Tailbay Scour Damages

Both of the 1973 & 2011 operations caused severe scour damage immediately downstream of the structure.

(2) The 2011 operation caused more scour damage to the immediate downstream areas of the MCS than the 1973 operation. Nine out of 15 scour indicators, anchored five feet below ground at the tailbay, disappeared during the operation. The largest scour hole was approximately 30 feet deep.

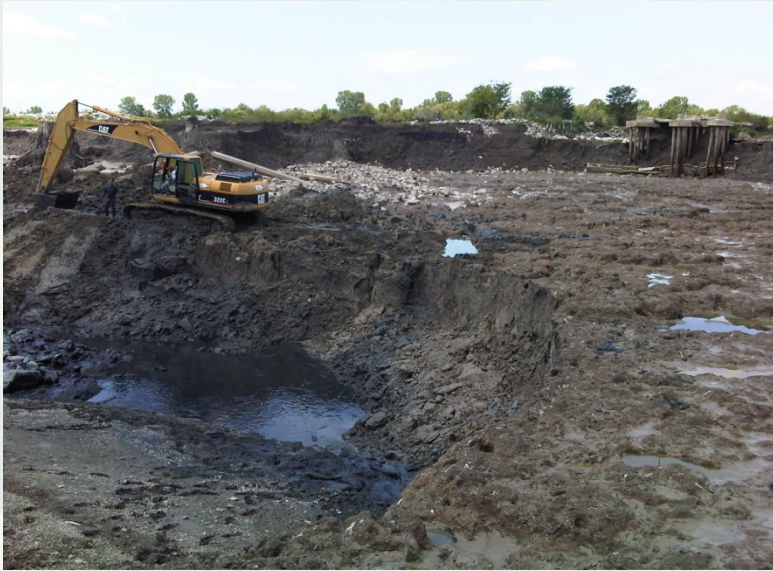
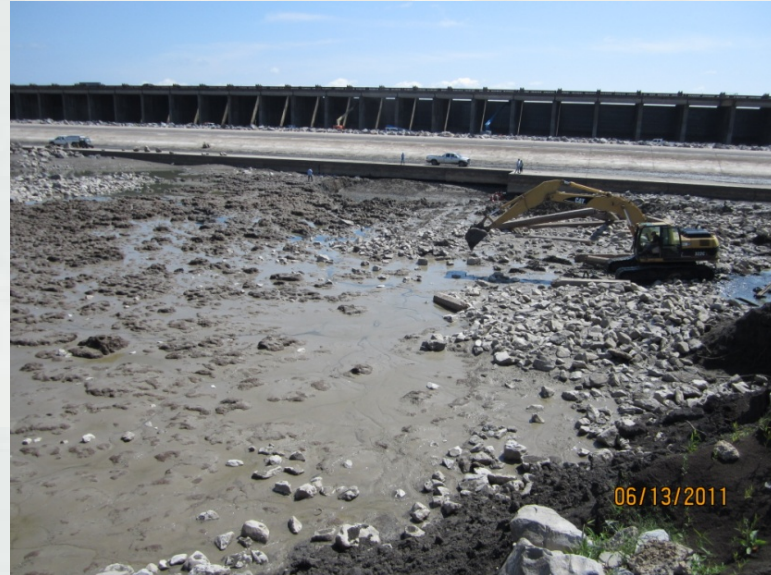
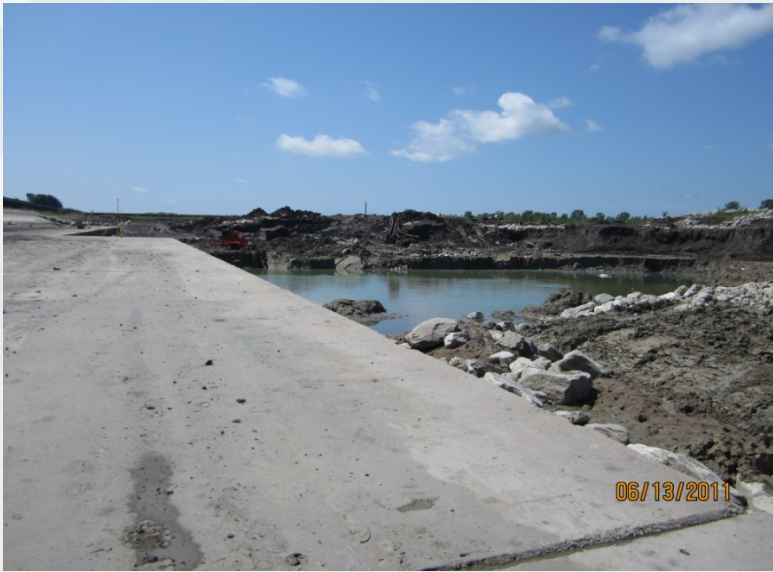
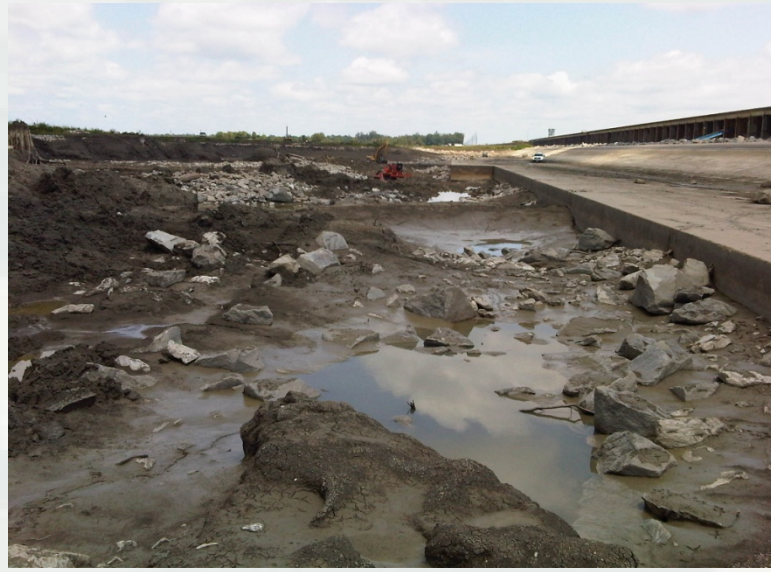
Un-watered Plunge Pool (13 June 2012)

- Un-watered plunge pool to perform assessment
- Investigated concrete slab
- Cored holes throughout concrete slab to determine the extent of undermining status
