Morganza Control Structure & the Mississippi River Flood Fight

T. (Jerry) Shih, Ph.D., P.E.
David J. Vossen, P.E.
Amena M. Henville, P.E., PMP

U.S. Army Corps of Engineers
New Orleans District
April 15, 2019

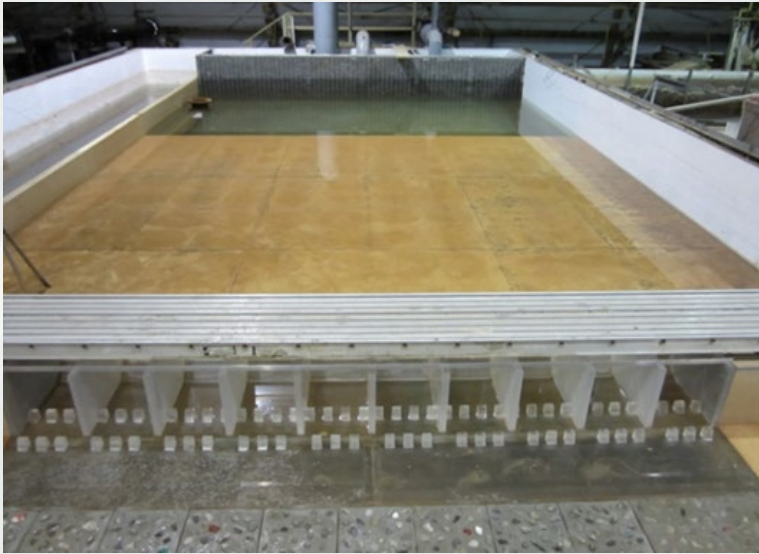
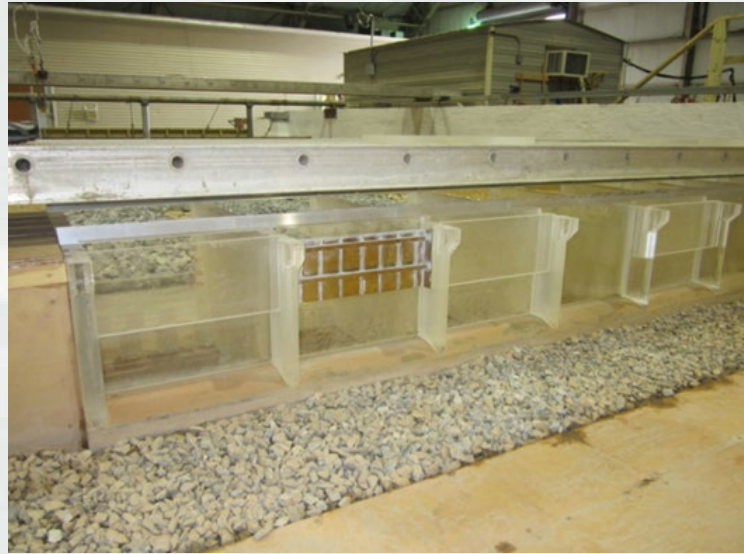
ERDC's Physical Model

- The first 1:22 scale-down physical model simulated 10 gates bays according to the plunge pool configuration.
- After completing the plunge pool modeling, the tailbay portion of the model was reconfigured to include the stilling basin configuration without a plunge pool.

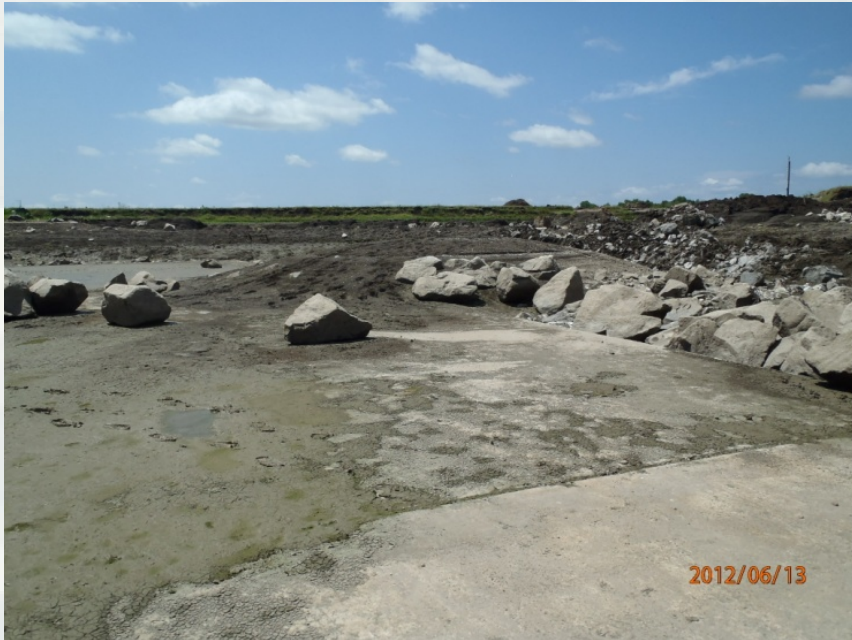
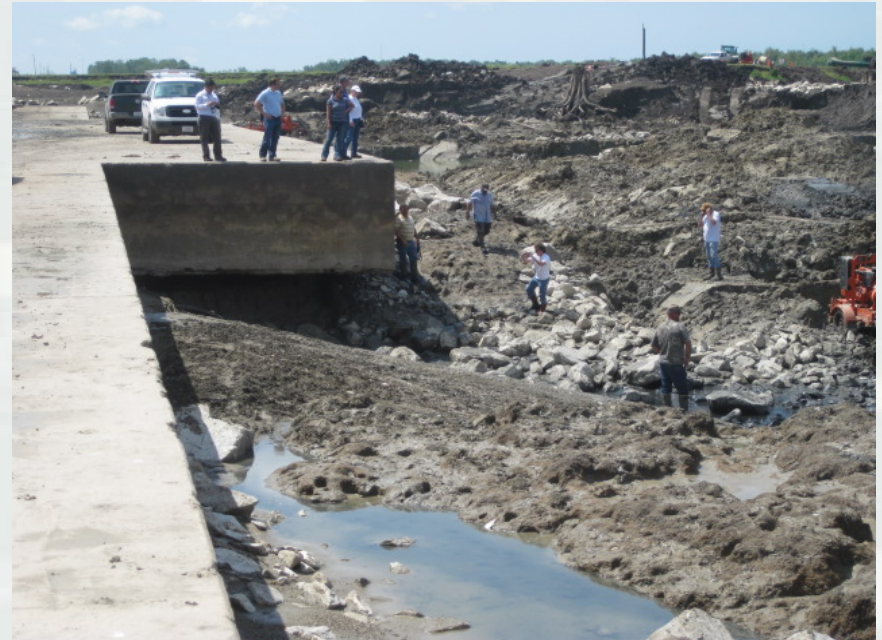
Full Damage Assessment

- Un-watered plunge pool to perform assessment
- Investigated concrete slab
- Cored holes throughout concrete slab to determine the extent of undermining status
